Public Works Commissioner Macomb County

## Rotted sewer pipe causes sinkhole in Warren

Cement filling and spray lining of underground pipe will prevent larger collapse.

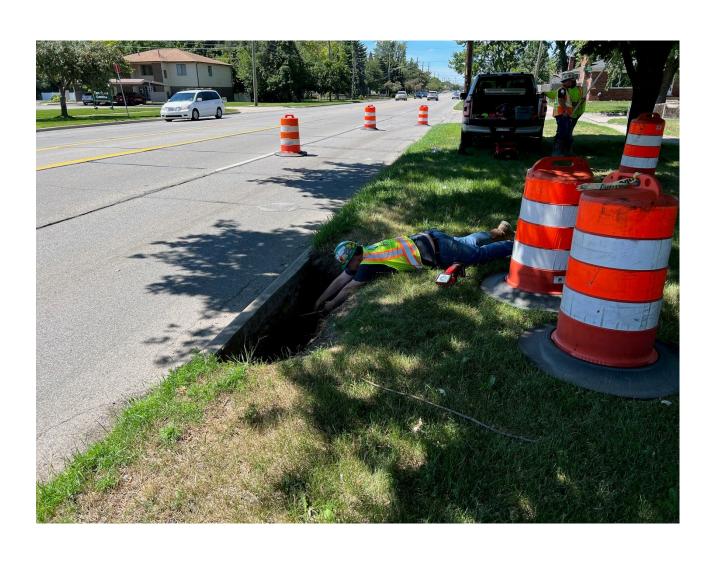
After the sinkhole was discovered along the curb of westbound 10 Mile Road at Loretta Avenue, west of Mound Road, inspection revealed that the bottom of a 30-foot-long portion of the elliptical, corrugated metal pipe measuring 11 feet wide in the enclosed part of the Bear Creek Drain had rotted. Storm water got through those openings and caused some of the gravel and dirt bed beneath and around the pipe to be washed away, eventually causing the sinkhole.

An inspector checks the sinkhole along westbound 10 Mile Road near Mound Road in Warren, prior to repair inside the Bear Creek Drain sewer pipe.

The contractor installed temporary internal bracing inside the pipe to stabilize it, and hydraulic cement was used to fill the holes at the bottom of the pipe and in the sinkhole. The crew working inside the pipe applied a coat of geo-polymer spray on the interior of the metal pipe before installing a carbon fiber grid. That was followed by a second spray coat to complete the rehabilitation of the interior of the pipe which was installed in the early 1960s.

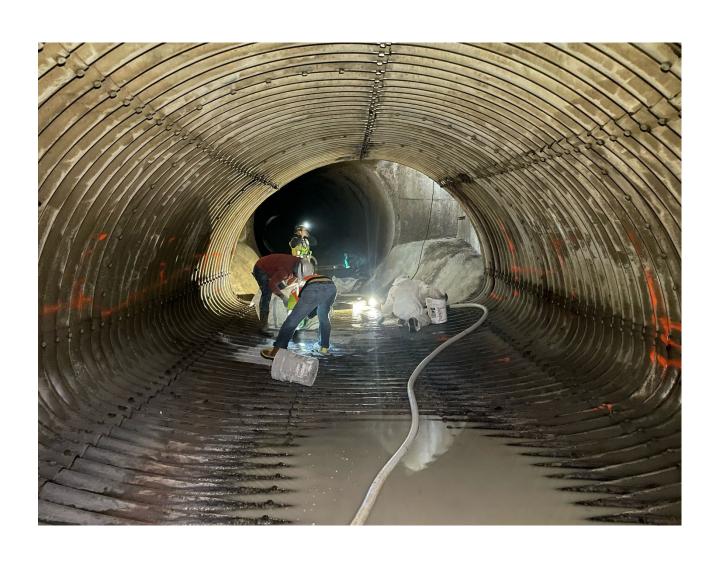
The contractor begins working inside the 11-foot-wide, 8-foot-high elliptical corrugated metal pipe that is part of an enclosed stretch of the Bear Creek Drain.

The spray-lining method used by the contractor was efficient with long-term protection of the sewer without the alternative of excavation to reach the rotted pipe, tear it out and replace it with new pipe. Its use by Macomb County in the Bear Creek Drain and an unrelated sewer rehabilitation project along 15 Mile Road is the first of its kind in Michigan.

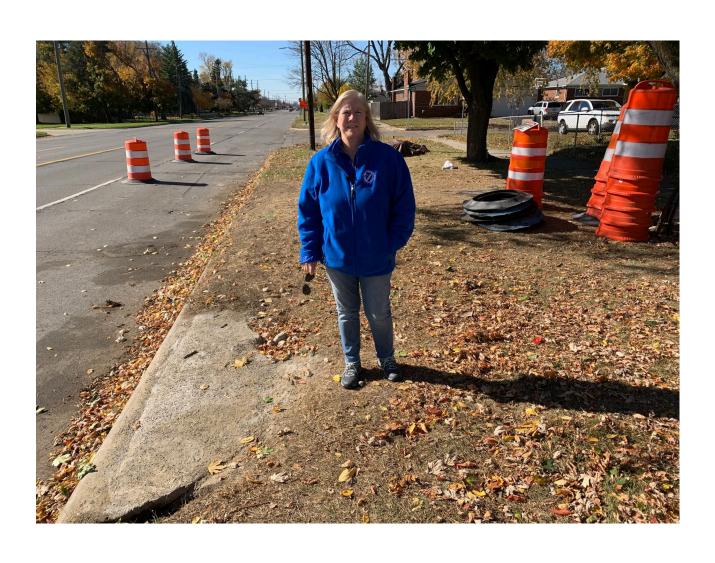
Macomb County Public Works Commissioner Candice S. Miller stands at the filled sinkhole along 10 Mile Road, west of Mound Road, in Warren.

After some additional follow-up inspection, the project is expected to be completed soon with some grouting on the outside of the pipe, up to the sinkhole.
