TURF REINFORCEMENT MAT ON A SLOPE

(SESC-50)

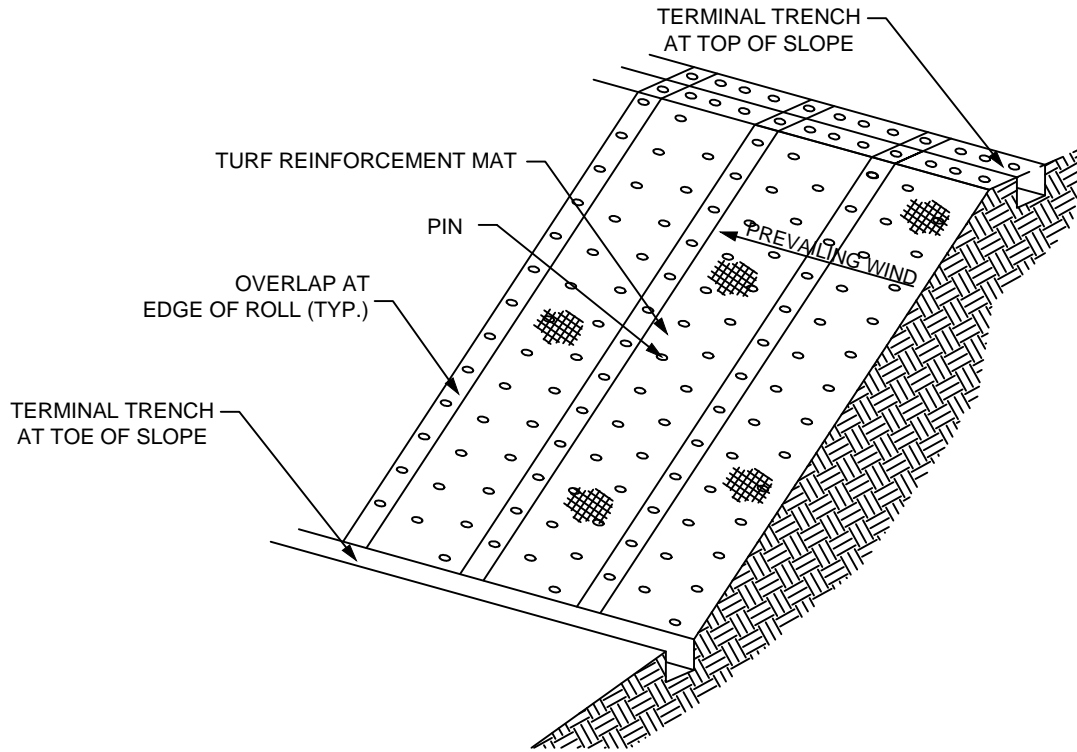
OVERVIEW OF TURF REINFORCEMENT MAT ON A CHANNEL BANK

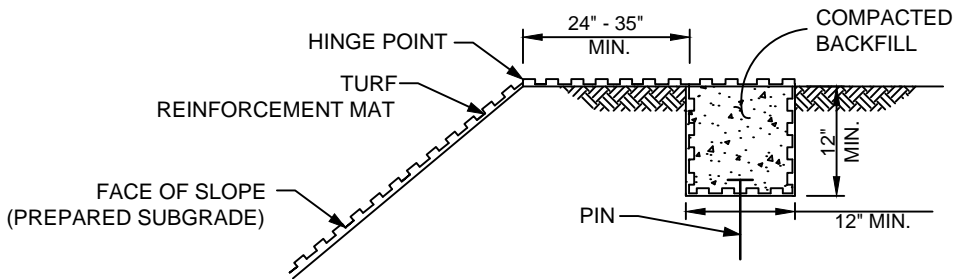
INITIAL TRENCH AT TOP OF SLOPE DETAIL

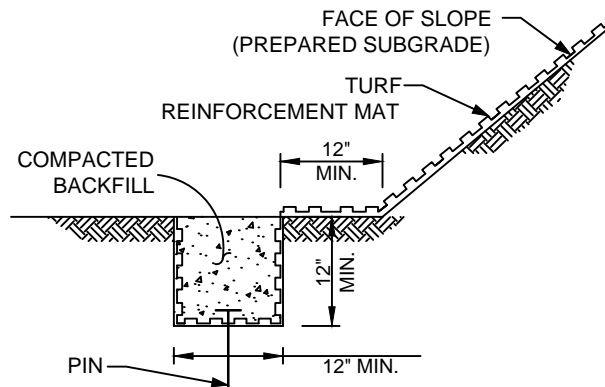
TERMINAL TRENCH AT TOE OF SLOPE DETAIL
